EB122 - PAVING FABRIC INTERLAYER AS A PAVEMENT MOISTURE BARRIER

The objective of this Engineering Bulletin is to provide a source of background information for persons who are unfamiliar with the use of geotextiles, commonly referred to as paving fabrics, as moisture barriers in pavements. The problem of moisture in pavements is first reviewed. This document then presents the mechanics by which moisture barriers work and provides a summary of work conducted by others in investigating their effectiveness. Also provided, is a reference list of other works, which have been used in developing the report.

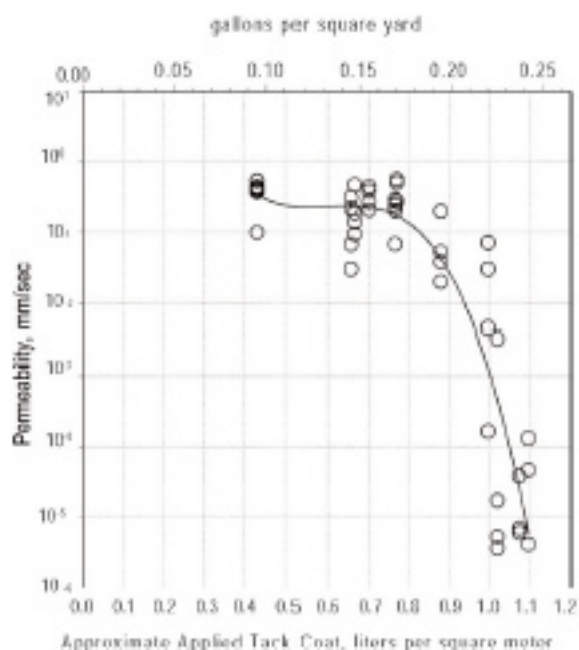
The results of permeability tests performed on specimens cut from the asphalt absorption tests are shown in Figure 1. Applied tack coat values shown on Figure 1 include the amount of asphalt actually absorbed into the paving fabric during these tests plus 0.23 liters per square meter (0.05 gallons per square yard) which is typically required to bond the interlayer to the pavement layers. On Figure 1 it can be seen that minor improvement in waterproofing can be expected until the tack coat application is at levels above 0.91 liters per square meter (0.23 to 0.24 gallons per square yard). At tack coat levels above 1.04 to 1.09 liters per square meter (0.23 to 0.24 gallons per square yard) the paving fabric starts to achieve permeabilities of 10-5mm/sec or less which will greatly enhance the waterproofing of a pavement. These levels are consistent with manufacturer's recommended tack coat rates for paving fabrics of the weights used in this study.

Figure 1 - Paving Fabric Permeability as Function of Tack Coat Application

For the paving fabric used in this investigation the manufacturer recommends a tack coat application rate of 1.13 liters per square meter (0.25 gallons per square yard), anticipating that about 0.23 liters per square meter (0.05 gallons per square yard) will be absorbed by the existing pavement and the new overlay. This implies that 0.91 liters per square meter (0.20 gallons per square yard) will be available to the paving fabric. If a tack coat rate of only 0.91 liters per square meter (0.20 gallons per square yard) is applied to a pavement the results of these tests indicate that the fabric would be allowed to absorb only about 0.68 liters per square meter (0.15 gallons per square yard).

densities and permeabilities can be widely variable due to compactive efforts. The principal causes for variations in the paving fabric interlayer system permeability are the amount and uniformity of the asphalt cement tack coat. The amount of tack coat should be a controllable amount. Although easily monitored, this is probably the greatest concern with paving fabric interlayer systems--making sure that the fabric is installed with sufficient tack asphalt to become impermeable which is essential to the performance of paving fabric systems.
